ADDENDUM No. 1

**The Municipality of Central Manitoulin
Public Works Garage Repairs
TULLOCH Project 240701**

Re: Focused Designated Substance and Hazardous Materials Survey
Municipality of Central Manitoulin, Mindemoya Road Garage Repairs, Mindemoya,
Ontario

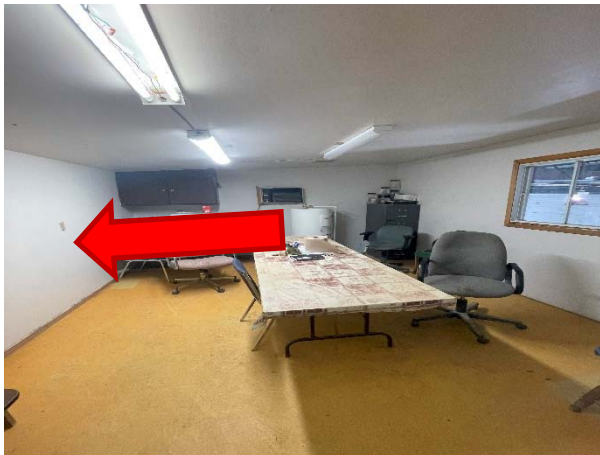
Drywall joint compound was found in the meeting room; however, this area was outside the scope of the work planned for the Site.

Drywall joint compound was outside of the scope of work for the repairs.

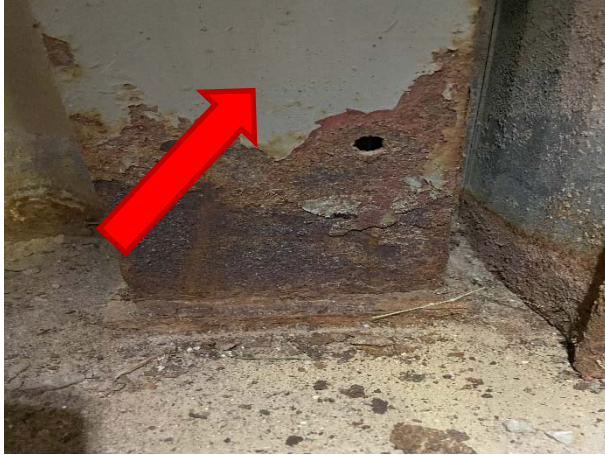
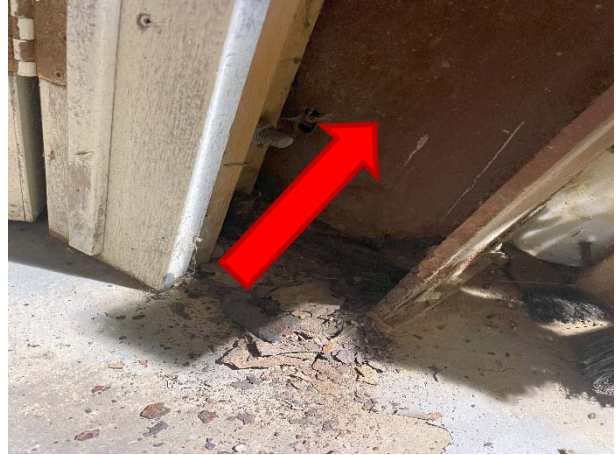
Painted surfaces with a glossy finish, typically indicative of lead-based paint, were found throughout the Site. No paint samples were collected from surfaces inside the building which will potentially be disturbed during demolition/renovation and analysed to determine the concentration of lead. Any paint that may be disturbed should be considered lead containing and appropriate procedures should be utilized.

Grey paint on steel columns is assumed to contain lead. Brown paint on steel columns is assumed to contain lead.

All paint assumed to contain lead should be abated prior to demolition if the substrate will be disturbed, cut, burnt, or abraded during demolition/removal. If items can be removed without cutting, burning, or abrading then abatement of lead containing paint is not required. Additional testing of assumed lead containing paint may be required to determine abatement options.

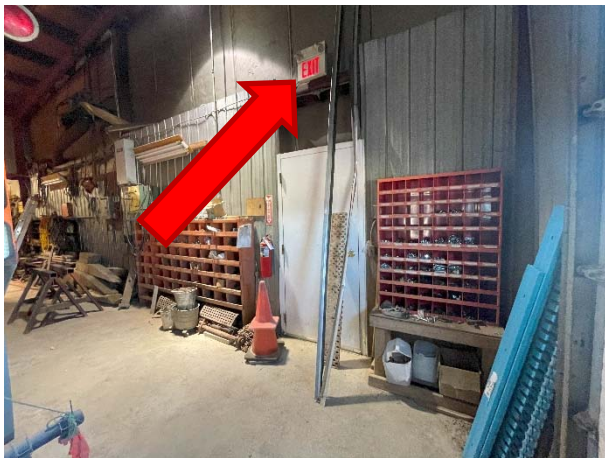
Lead will be present in any lead-acid batteries for emergency lighting. Lead is considered to be present in wiring connectors, grounding conductors and solder.

Emergency lighting may contain lead-acid batteries.

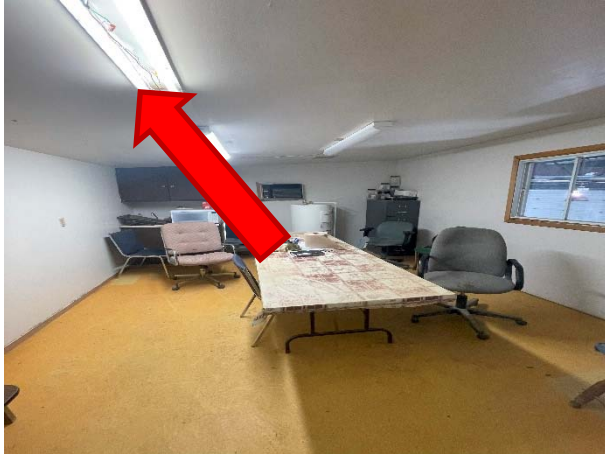
At the time of our visit, fluorescent lamps were observed throughout the survey area. Fluorescent lamps contain mercury vapour. Fluorescent lamps should be removed intact and properly disposed of.

Florescent lamp tubes contain mercury vapour.

Materials consisting of elemental, inorganic or organic mercury that exceed the Leachate Quality Criteria of 0.1 ppm, as established by Regulation 347 (as amended) TCLP, cannot be disposed of at a solid non-hazardous waste site. The waste removal contractor should be responsible for finding a source for the disposal of materials containing mercury. Mercury is also listed in the “*Transportation of Dangerous Goods Act*,” therefore, specific requirements apply for the transportation of materials containing mercury.
